Manhole Inspection Summary

Manhole # S150__050MH

Insp Date: **2/24/09 3:35 PM**

Location Address: **2660 LEHMAN ST**

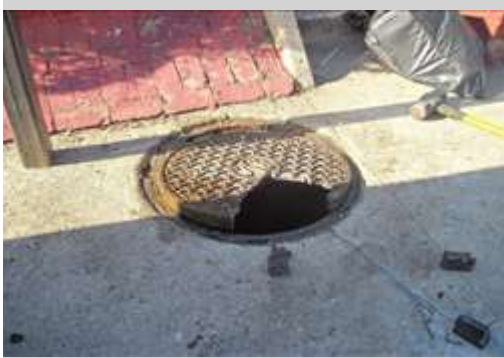
Miscellaneous

HAD TO BREAK OPEN PREVIOUS LID

Comments **OBSERVED MH WITH WATERTIGHT COVER THAT IS SEALED IN FRAME - BROKE OPEN WITH 16LB MAUL AND REPLACED WITH NEW 24" SANITARY LID. INSPECTION COMPLETE.**

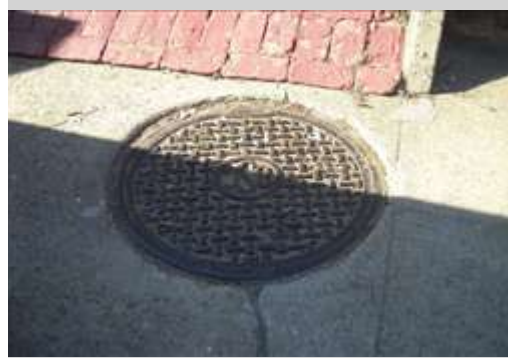
Miscellaneous

MH SUBJECT TO PONDING - SITS ENTIRELY BELOW GRADE IN SIDEWALK

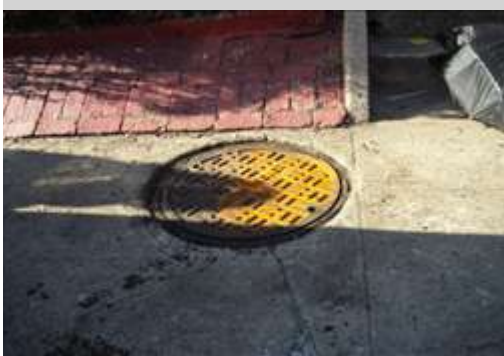
Miscellaneous

REPLACED BROKEN AND STUCK COVER WITH NEW 24" SANITARY LID

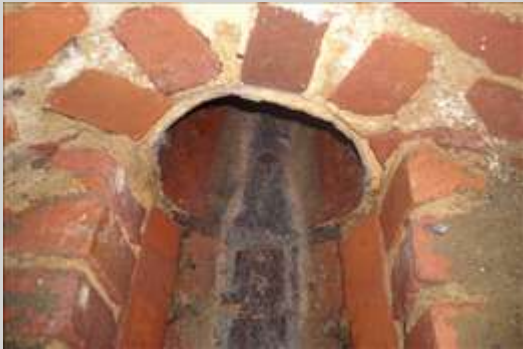
12 O'Clock Outflow

10 in. Circular Gravity Sewer
Pipe Out @ 12 O'Clock

Pipe Height: **9.6** (in.) Rod and Bar (Angled)
Pipe Material: **Clay** ☐ Pipe Lined
Invert Depth: **5.48** (ft.) Flow Characteristics: **Slow**
Deposits: ☒ None ☐ Mud ☐ Sludge ☐ Debris ☐ Grease
Silt Depth: **0** (in.) Deposits Extent:
Infiltration: **None** Pipe Seal Cond: **Sound**

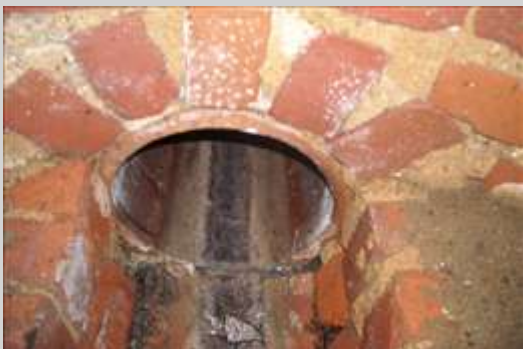
6 O'Clock Inflow

10 in. Circular Gravity Sewer
Pipe In @ 6 O'Clock

Pipe Height: **9.6** (in.) Rod and Bar (Angled)
Pipe Material: **Clay** ☐ Pipe Lined
Invert Depth: **5.41** (ft.) Flow Characteristics: **Slow**
Deposits: ☒ None ☐ Mud ☐ Sludge ☐ Debris ☐ Grease
Silt Depth: **0** (in.) Deposits Extent:
Infiltration: **None** Pipe Seal Cond: **Sound**
